MINISTRY OF ROADS AND TRANSPORT  
STATE DEPARTMENT FOR TRANSPORT  
**AIRCRAFT ACCIDENT INVESTIGATION DEPARTMENT**

INVESTIGATION REPORT /03/2024

**PRELIMINARY INVESTIGATION REPORT ON THE MIDAIR  
COLLISION ACCIDENT INVOLVING CESSNA C172M AIRCRAFT  
REGISTRATION 5Y-NNJ AND BOMBARDIER DE HAVILLAND  
DASH 8 DHC 8-315 AIRCRAFT REGISTRATION 5Y-SLK, ON 05  
MARCH 2024 AT THE NAIROBI NATIONAL PARK, NAIROBI  
COUNTY**

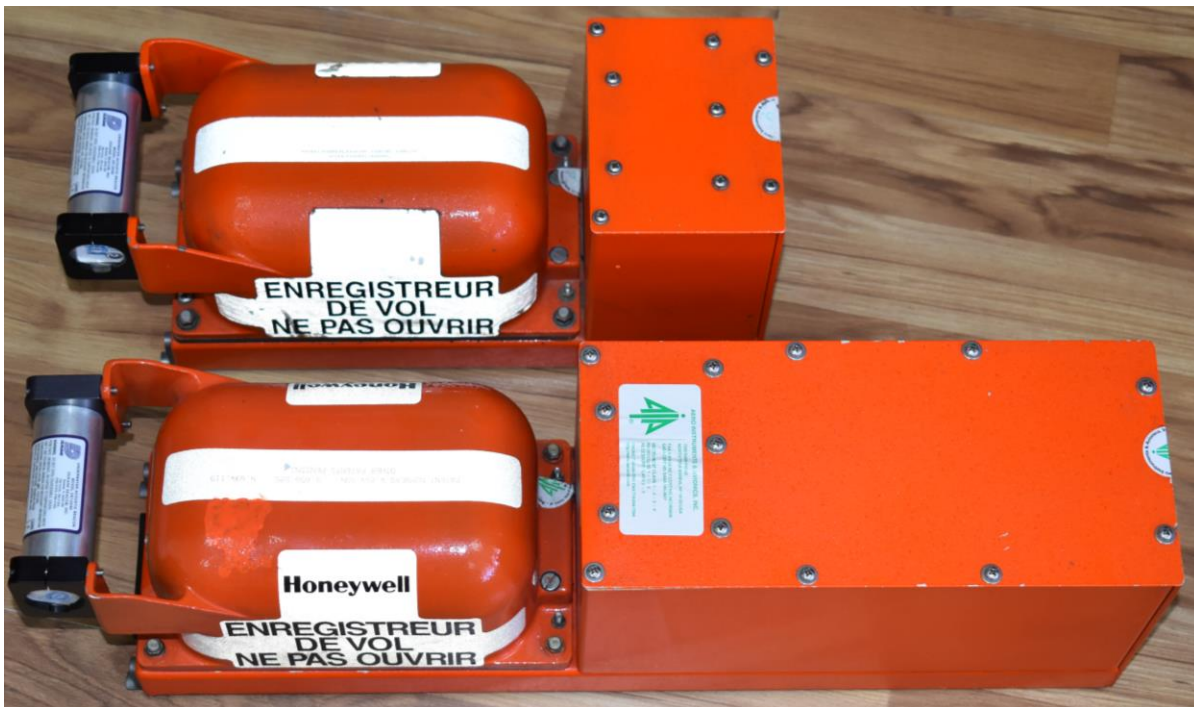
*FIGURE No. 9 – A photo depicting the Cockpit Voice Recorder (upper) and Flight Data Recorder*

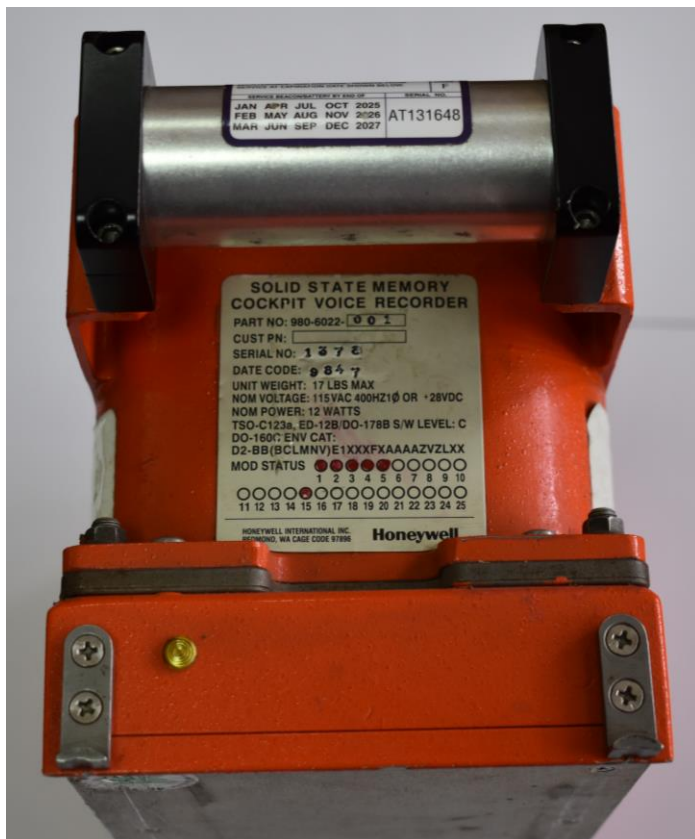
*FIGURE No. 10 – A photo depicting the Cockpit Voice Recorder*

A Honeywell solid state memory Cockpit Voice Recorder (CVR) Part No. 980-6022-001, Serial No. 1378, data code 9847 was recovered from the aircraft in good condition. The CVR will be read out and analysed as early as possible in a read-out facility at the TSB-Canada under the supervision of the Investigator-In-Charge (IIC).

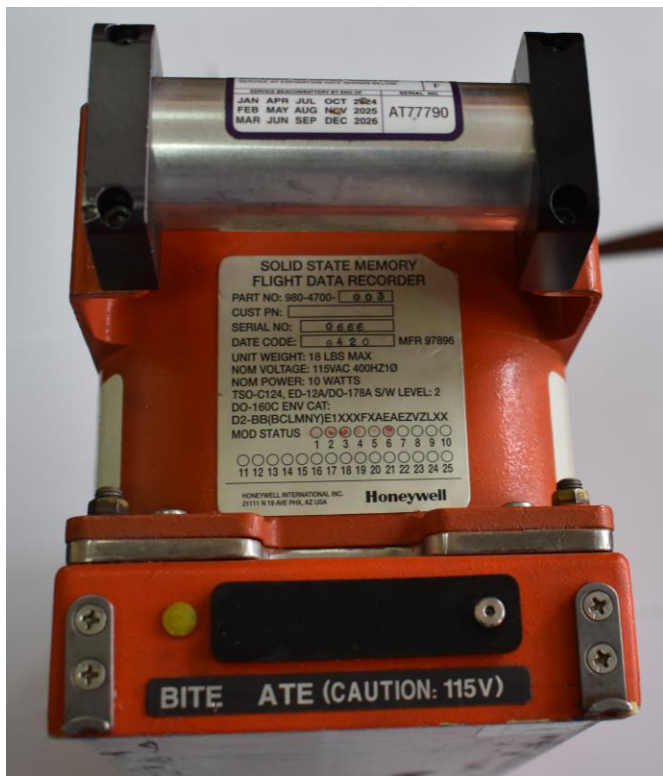
**FIGURE No. 11** – A photo depicting the Flight Data Recorder

A Honeywell solid state memory Flight Data Recorder (FDR) Part No. 980-4700-003, Serial No. 0666 data code 9420 (MFR 97896) was recovered from the aircraft in good condition. The FDR will be read out and analysed as early as possible in a read-out facility at the TSB-Canada under the supervision of the Investigator-In-Charge (IIC).
